Reserve Study Transmittal Letter

Re: Glenshire Devonshire Residents Association; Update w/ Site Visit Review

Prepared for the 2022 Fiscal Year

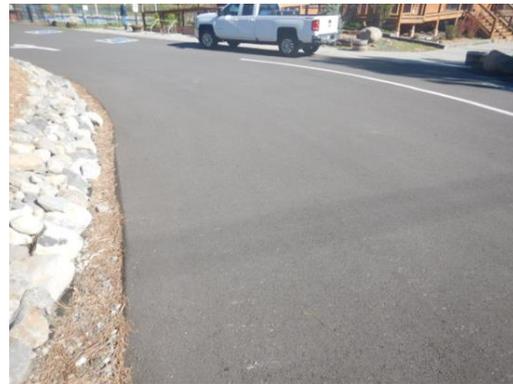
01000 - Paving

2020- \$130,225 was expended for a completed remove and replace.

2016- The paving is at the end of its useful life. This component is scheduled to happen 6 years after the 2021 major paving rehab.

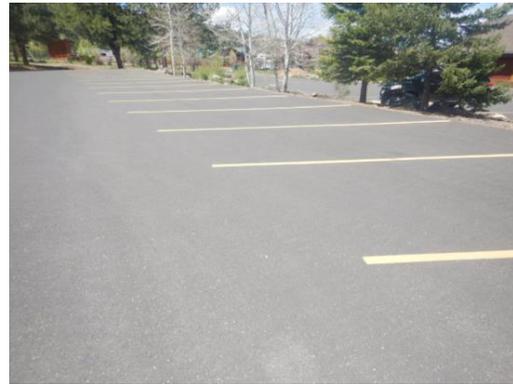
02000 - Concrete

220 - Walkways 4,130 sf Clubhouse Perimeter (50%)	Useful Life 20 Remaining Life 1 Quantity 4,130 Cost /SqFt \$14.00 % Included 50.00%	Unit of Measure Square Feet Qty * \$/SqFt \$57,820 Total Cost/Study \$28,910 Replacement Year 2022 Future Cost \$29,633
Summary

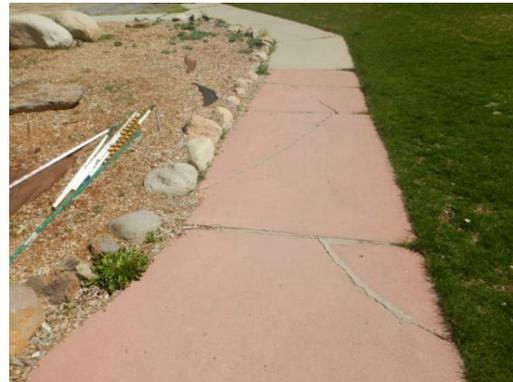
400 - Pavers 8,240 sf Pool Deck	Useful Life 30 Remaining Life 25 Quantity 8,240 Cost /SqFt \$9.80 % Included 100.00%	Unit of Measure Square Feet Total Cost/Study \$80,752 Replacement Year 2046 Future Cost \$149,710
Summary

2016- There is a failure area at the northeast side of the clubhouse near the tennis court entry.

This is to repair and replace the concrete pavers.

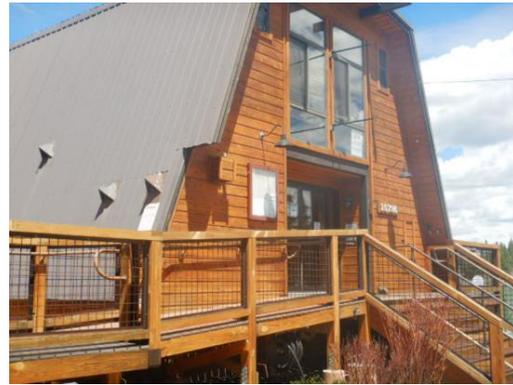
208 - Siding 2,471 sf Pool Building	Useful Life 30 Remaining Life 25 Quantity 2,471 Cost /SqFt \$30.00 % Included 100.00%	Unit of Measure Square Feet Total Cost/Study \$74,130 Future Cost \$137,433
Summary	Replacement Year 2046

2021- The clubhouse siding is in fair to good condition. Reduced useful life from 30 to 25 years and replacement scope from 100% to 50%.
 1999- Placed in service.

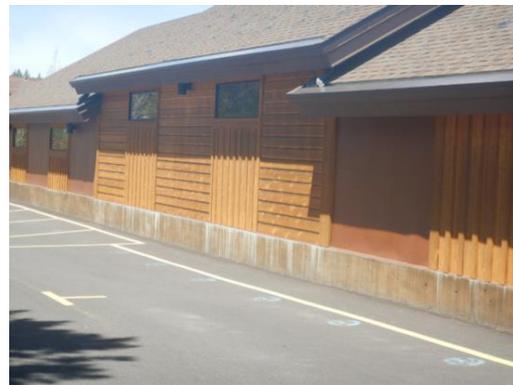
04000 - Structural Repairs

2021- The siding has a dry appearance and needs sealing.
 2016- Placed in service.

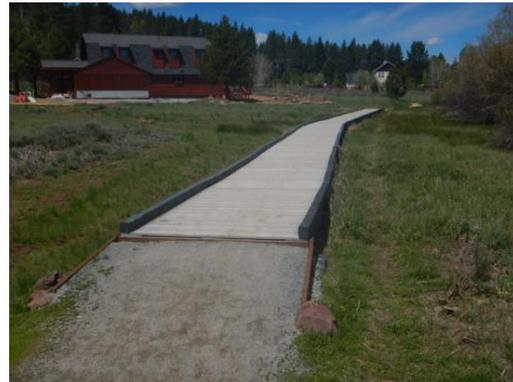
04000 - Structural Repairs

2021- Remaining life extended from 2021 to 2022 per client. Most transitions from decomposed granite to decking are vertical displacements.
 2016- Major percentage of the walks were placed in service in 2006 per information received. Client provided information will further define this component.

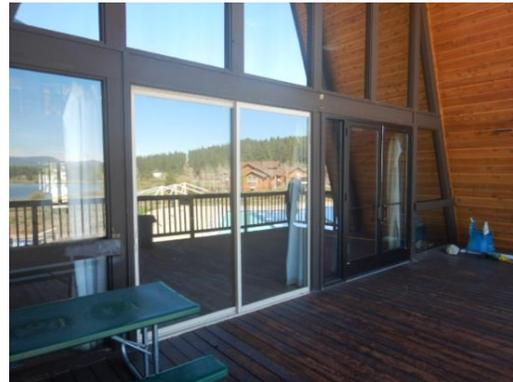
920 - Doors	Useful Life 30	Remaining Life 8
10 Clubhouse Interior Doors	Quantity 10	Unit of Measure Items
	Cost /Itm \$910	
	% Included 100.00%	Total Cost/Study \$9,100
Summary	Replacement Year 2029	Future Cost \$11,087

This is to replace the interior doors.

2021- Per client 9/15/2021, quantity increased from 5 to 10.
 1999- Placed in service.

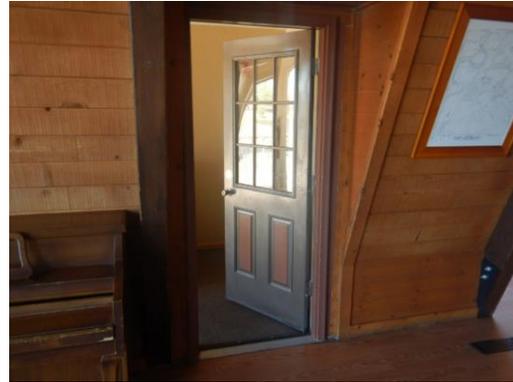
924 - Doors	Useful Life 30	Remaining Life 25
7 Pool Building	Quantity 7	Unit of Measure Items
	Cost /Itm \$1,980	
	% Included 100.00%	Total Cost/Study \$13,860
Summary	Replacement Year 2046	Future Cost \$25,696

This is to repair, replace and maintain the doors.

- 1- interior
- 2- exterior
- 4- utility

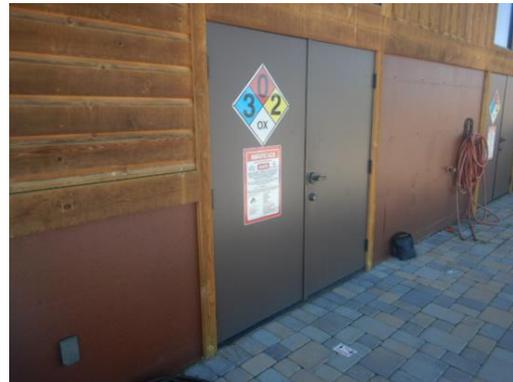
928 - Doors	Useful Life 30	Remaining Life 25
Pool Building Overhead Roll-Up Door	Quantity 1	Unit of Measure Items
	Cost /Itm \$1,130	
	% Included 100.00%	Total Cost/Study \$1,130
Summary	Replacement Year 2046	Future Cost \$2,095

This is to replace the pool pass building maintenance 10'x10' overhead door.

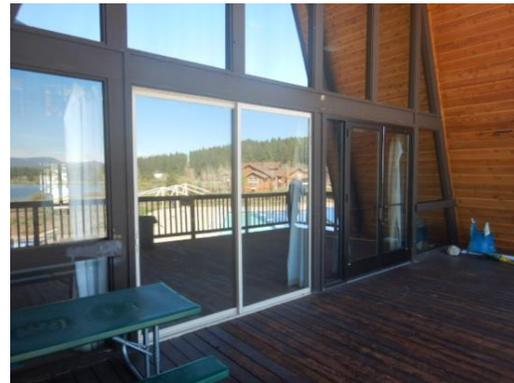
940 - Windows	Useful Life 30	Remaining Life 3	
Northeast Replacements	Quantity 1	Unit of Measure	Items
	Cost /Itm \$16,155		
Summary	% Included 100.00%	Total Cost/Study	\$16,155
	Replacement Year 2024	Future Cost	\$17,397

This is to replace the windows.

2021- Per client 9/15/2021, remaining life extended from 2022 to 2024.

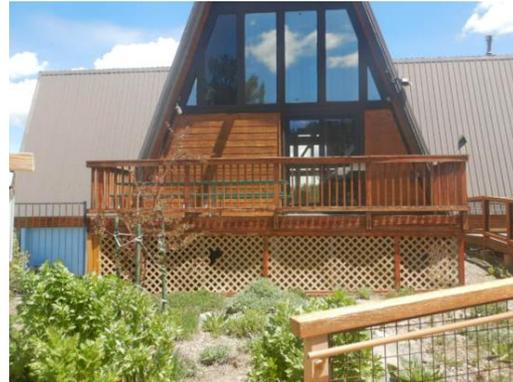
952 - Windows	Useful Life 30	Remaining Life 3
Front Replacements	Quantity 1	Unit of Measure Items
	Cost /Itm \$16,155	
	% Included 100.00%	Total Cost/Study \$16,155
Summary	Replacement Year 2024	Future Cost \$17,397

This is to replace the windows.

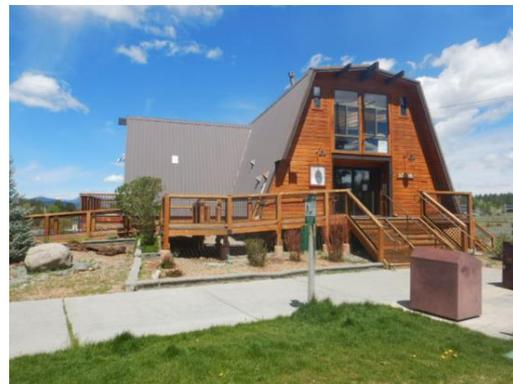
04500 - Decking/Balconies

2021- Per client 9/15/2021, remaining life extended from 2022 to 2024.

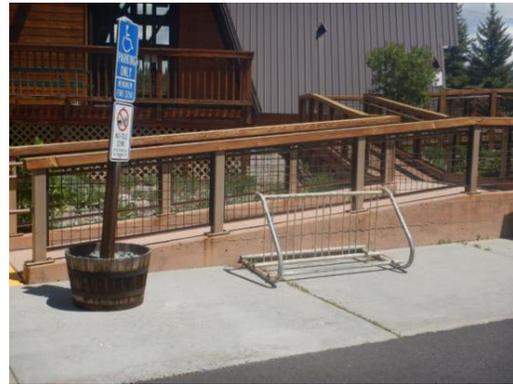
110 - Composite	Useful Life 40	Remaining Life 12
445 sf CH Front Entry-Decking/Railing Repair	Quantity 445	Unit of Measure Square Feet
	Cost /SqFt \$45.00	
	% Included 100.00%	Total Cost/Study \$20,025
Summary	Replacement Year 2033	Future Cost \$26,931

2013- \$102,000 (\$229 sf) was expended for the overall renovation project to replace the deck, railings, front stairs, handicap ramp and deck structure.

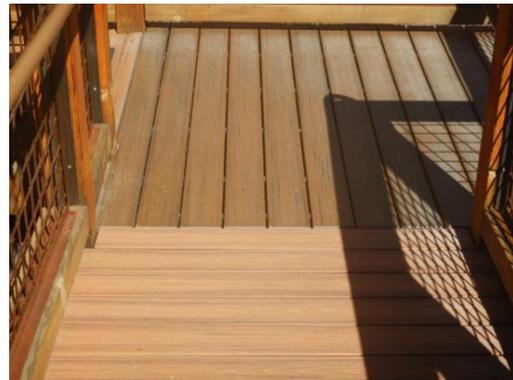
120 - Wood	Useful Life 40	Remaining Life 36
445 sf CH- Northeast Structural Mod	Quantity 445	Unit of Measure Square Feet
	Cost /SqFt \$90.00	
	% Included 100.00%	Total Cost/Study \$40,050
Summary	Replacement Year 2057	Future Cost \$97,423

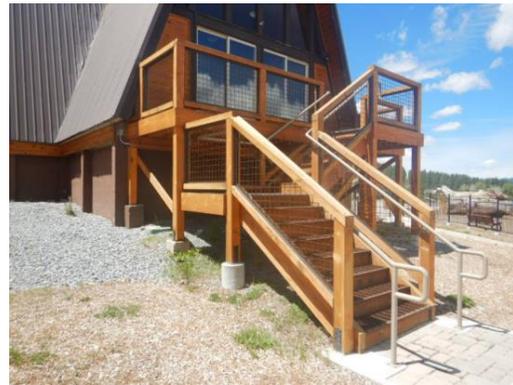
130 - Composite	Useful Life 40	Remaining Life 36
200 sf CH Northeast Decking/Railing Only	Quantity 200	Unit of Measure Square Feet
	Cost /SqFt \$45.00	
	% Included 100.00%	Total Cost/Study \$9,000
Summary	Replacement Year 2057	Future Cost \$21,893

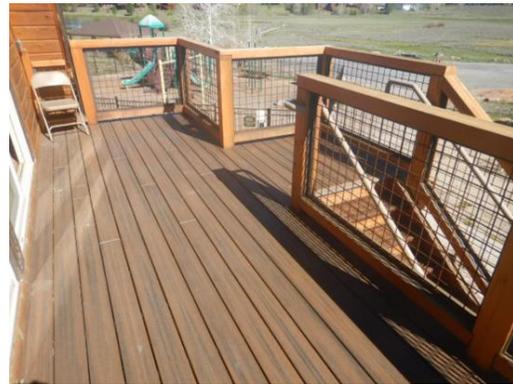
140 - Wood	Useful Life 40	Remaining Life 1
445 sf CH Southwest Structural Mod	Quantity 445	Unit of Measure Square Feet
	Cost /SqFt \$90.00	
	% Included 100.00%	Total Cost/Study \$40,050
Summary	Replacement Year 2022	Future Cost \$41,051

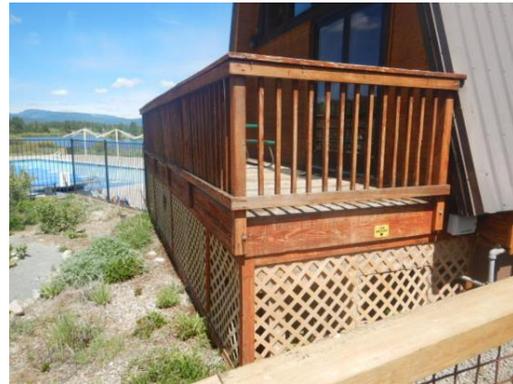
150 - Composite	Useful Life 40	Remaining Life 1
184 sf CH Southwest Decking/Railings	Quantity 184	Unit of Measure Square Feet
	Cost /SqFt \$45.00	
	% Included 100.00%	Total Cost/Study \$8,280
Summary	Replacement Year 2022	Future Cost \$8,487

2021- Remaining life extended from 2021 to 2022 per client.
 2018- Estimate increased slightly to match 2017 scope, and includes engineering and should be \$37,123.
 2017- Client advised to use \$32,000 for upcoming work. Later in 2017, per client, cost increased 10%.
 2016- Estimate based on \$102,000 for the 2013 renovation project to replace the clubhouse entrance deck structure, stairs, railings and handicap ramp.
 1995- Placed in service.

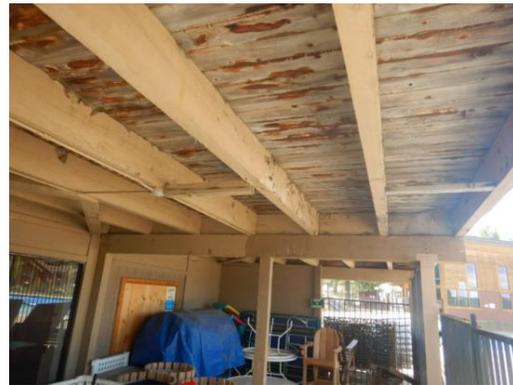
170 - Composite	Useful Life 40	Remaining Life 1
456 sf CH Northwest Decking/Railings	Quantity 456	Unit of Measure Square Feet
	Cost /SqFt \$45.00	
	% Included 100.00%	Total Cost/Study \$20,520
Summary	Replacement Year 2022	Future Cost \$21,033

This is to replace the NW (pool facing) wood decking surface with a composite material and to include railings as needed.

deck- 456 sf
 railings- 41 lf

2021- Remaining life extended from 2021 to 2022 per client. Increased estimate from \$23/sf to \$45/sf.

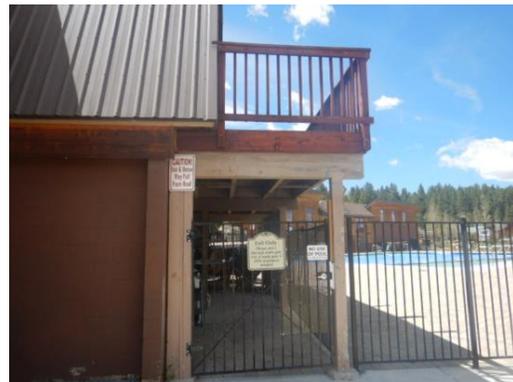
960 - CA Mandated Inspections	Useful Life 9	Remaining Life 3
2 Clubhouse Decks	Quantity 2	Unit of Measure Items
	Cost /Itm \$750	
	% Included 100.00%	Total Cost/Study \$1,500
Summary	Replacement Year 2024	Future Cost \$1,615

2 Decks, north and west, their railings & stairs will require inspection.
 South deck does not meet criteria for inspection.
 Front stairs and walk do not meet criteria for inspection.

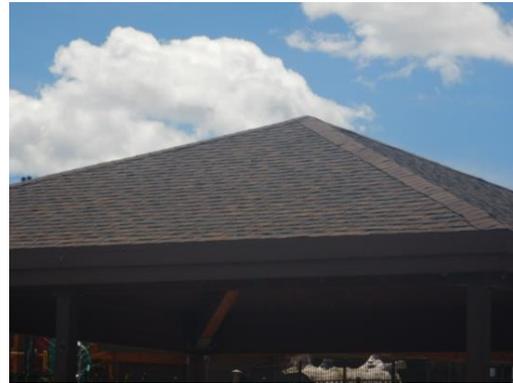
680 - Pitched: Metal 55 Squares- Clubhouse	Useful Life 40 Remaining Life 12 Quantity 55 Unit of Measure Squares Cost /Sqrs \$1,245 % Included 100.00% Total Cost/Study \$68,475 Replacement Year 2033 Future Cost \$92,091
Summary

This is to replace the metal roofing system.

2021- Increased useful life from 30 to 40 years and remaining life from 2023 to 2033.
 2016- Should client have this roofing assessed for cost to replace and timing, information received will further define this component.
 1993- Placed in service.

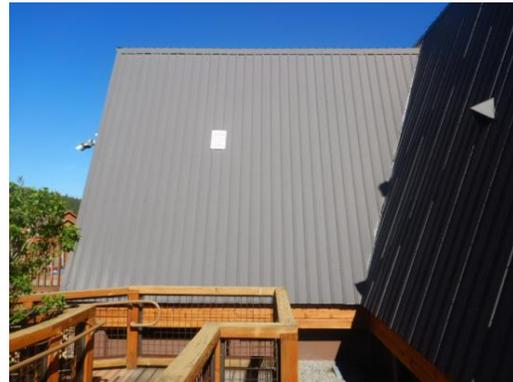
780 - Heat Tape	Useful Life 10	Remaining Life 5
110 lf Pool Building Roof	Quantity 110	Unit of Measure Linear Feet
	Cost /l.f. \$16.00	
	% Included 100.00%	Total Cost/Study \$1,760
Summary	Replacement Year 2026	Future Cost \$1,991

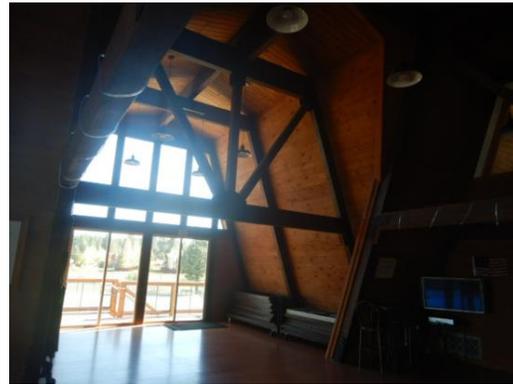
104 - General	Useful Life 25	Remaining Life 20
Pool Building Office	Quantity 1	Unit of Measure Room
	Cost /Rm \$5,090	
	% Included 100.00%	Total Cost/Study \$5,090
Summary	Replacement Year 2041	Future Cost \$8,341

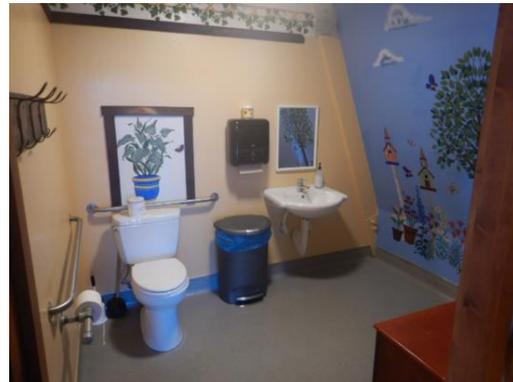
224 - Bathrooms	Useful Life 20	Remaining Life 13
2 Clubhouse Downstairs Pool Bathrooms	Quantity 2	Unit of Measure Room
	Cost /Rm \$7,000	
	% Included 100.00%	Total Cost/Study \$14,000
Summary	Replacement Year 2034	Future Cost \$19,299

- 1- urinal
- 4- showers
- 4- sinks
- 6- toilets
- 6-partitions- 46 lf

2021- Per client, the basement bathrooms were remodeled in 2014 for \$103,268. No work scope obtained. No break down on component cost such as tile, fixtures, etc. Increased estimate from \$4,525/rm to \$7,000/rm. Client input will further define this component.
 2014- Placed in service.

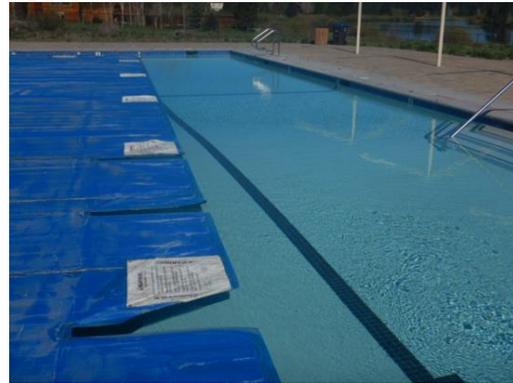
114 - Resurface	Useful Life 10	Remaining Life 0
51 lf Wading Pool	Quantity 51	Unit of Measure Linear Feet
	Cost /l.f. \$165	
	% Included 100.00%	Total Cost/Study \$8,415
Summary	Replacement Year 2021	Future Cost \$8,415

This is to resurface the pool including start-up costs.

2021- Work is anticipated per client.
 2020- Per client 10/14/2020, move to 2021 for replacement cost of \$8,500
 2019- Client advised this is being done in 2019. Later moved to 2020.
 2016- \$155,000 total was expended for complete main and wading pool rehabs.

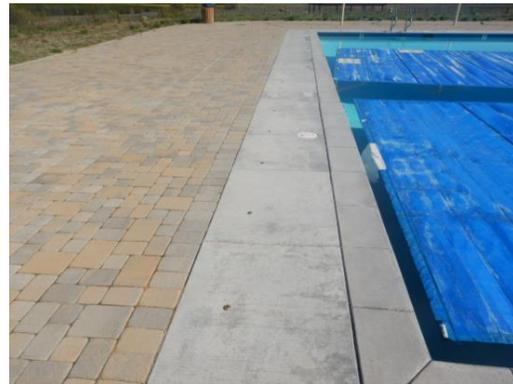
204 - Edge: Tile, Coping, Mastic	Useful Life 24	Remaining Life 19
51 lf Wading Pool	Quantity 51	Unit of Measure Linear Feet
	Cost /l.f. \$50.00	
	% Included 100.00%	Total Cost/Study \$2,550
Summary	Replacement Year 2040	Future Cost \$4,077

This is to replace the tile, coping and mastic in conjunction with every other resurfacing cycle.

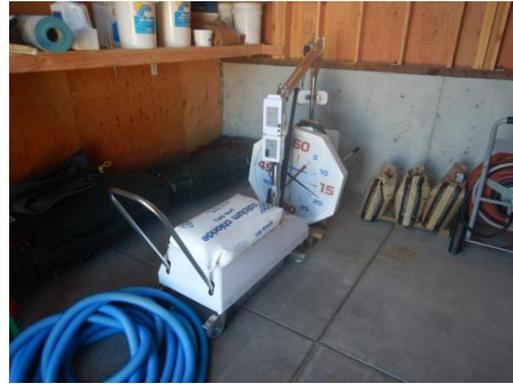
400 - ADA Chair Lift Wading Pool	Useful Life 10 Remaining Life 4 Quantity 1 Unit of Measure Items Cost /Itm \$9,050 % Included 100.00% Total Cost/Study \$9,050 Replacement Year 2025 Future Cost \$9,990
-------------------------------------	--

This is to replace the pool's Spectrum Aquatics ADA compliant chair lift.

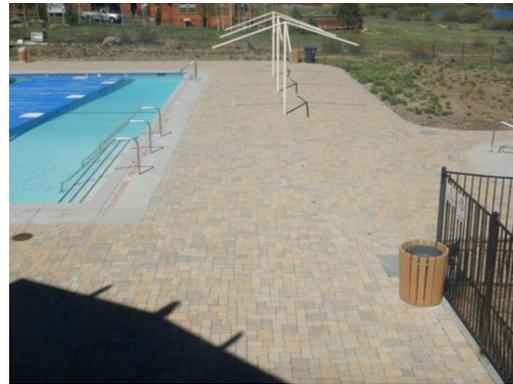
640 - Deck: Replace Lap & Wading Pool Deck Pavers	Useful Life 40 Remaining Life 35 Quantity 1 Unit of Measure Lump Sum Cost /LS \$33,770 % Included 100.00% Total Cost/Study \$33,770 Replacement Year 2056 Future Cost \$80,143
--	--

This is to replace the pool area pavers.

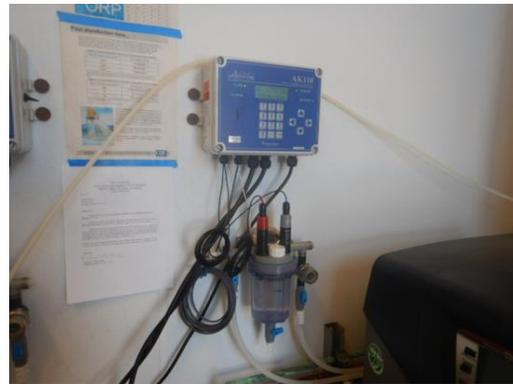
700 - Chemical System	Useful Life 10	Remaining Life 5
Lap Pool Acu-Trol AK110 Chemical Controller	Quantity 1	Unit of Measure System
	Cost /Sys \$4,200	
	% Included 100.00%	Total Cost/Study \$4,200
Summary	Replacement Year 2026	Future Cost \$4,752

This is to replace the chemical feed equipment.

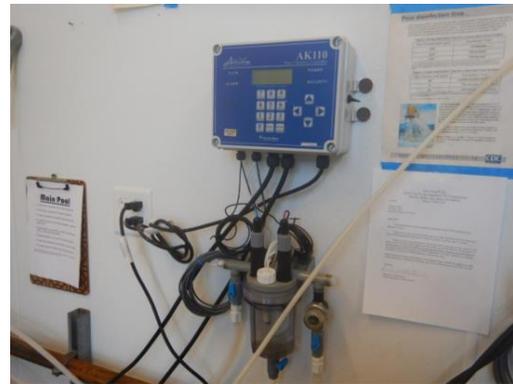
704 - Chemical System	Useful Life 10	Remaining Life 5
Wading Pool Acu-Trol AK110 Chemical Controller	Quantity 1	Unit of Measure Items
	Cost /Itm \$4,200	
	% Included 100.00%	Total Cost/Study \$4,200
Summary	Replacement Year 2026	Future Cost \$4,752

This is to replace the chemical feed equipment.

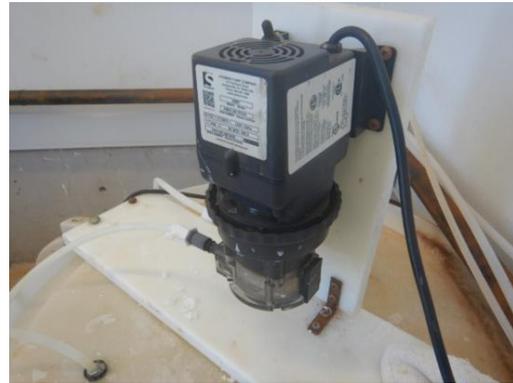
712 - Chemical System	Useful Life 5	Remaining Life 5
2 Wading Pool Stenner Pumps	Quantity 2	Unit of Measure Items
	Cost /Itm \$675	
	% Included 100.00%	Total Cost/Study \$1,350
Summary	Replacement Year 2026	Future Cost \$1,527

This is to replace the wading pool Stenner pumps.

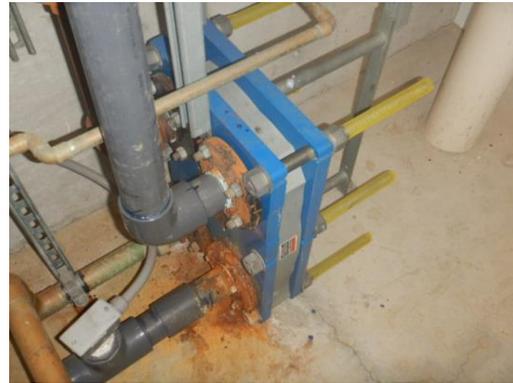
716 - Equipment: Replacement	Useful Life 5	Remaining Life 0
Lap Pool Sondex Heat Exchanger	Quantity 1	Unit of Measure Items
	Cost /Itm \$4,000	
	% Included 100.00%	Total Cost/Study \$4,000
Summary	Replacement Year 2021	Future Cost \$4,000

This is to replace the lap pool Sondex model S9A1G10-25 heat exchanger.

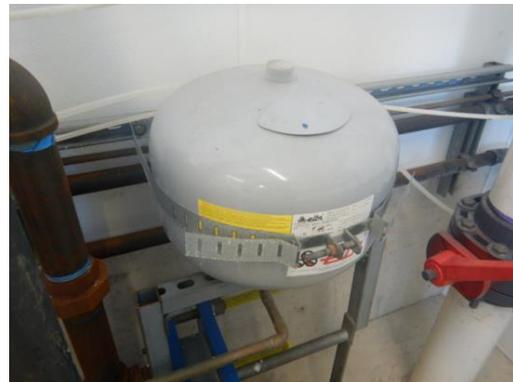
720 - Equipment: Replacement	Useful Life 20	Remaining Life 15
2 Lap Pool Pressure Tanks	Quantity 2	Unit of Measure Items
	Cost /Itm \$675	
	% Included 100.00%	Total Cost/Study \$1,350
Summary	Replacement Year 2036	Future Cost \$1,955

This is to replace the lap pool pressure tanks.

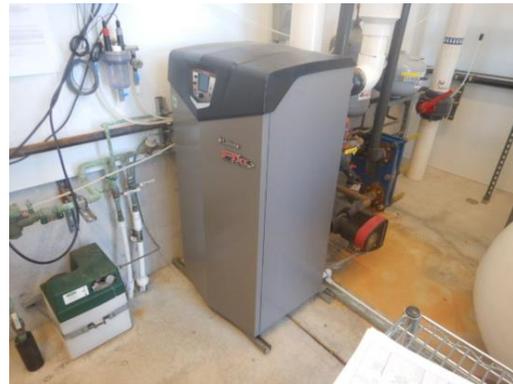
724 - Heater	Useful Life 10	Remaining Life 5
Lap Pool Boiler	Quantity 1	Unit of Measure Items
	Cost /Itm \$27,150	
	% Included 100.00%	Total Cost/Study \$27,150
Summary	Replacement Year 2026	Future Cost \$30,718

This is to replace the Lochinvar FTxL fire tube boiler water heater.

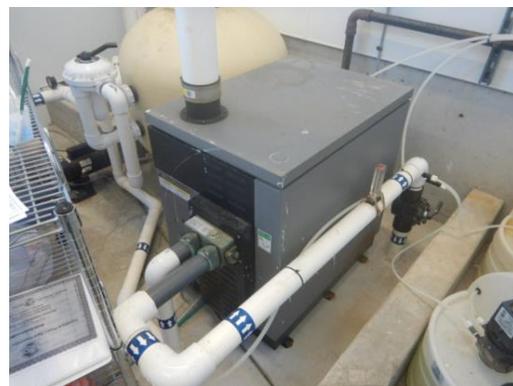
728 - Heater	Useful Life 10	Remaining Life 5
Wading Pool	Quantity 1	Unit of Measure Items
	Cost /Itm \$7,920	
	% Included 100.00%	Total Cost/Study \$7,920
Summary	Replacement Year 2026	Future Cost \$8,961

This is to replace the wading pool Jandy HiE2 water heater.

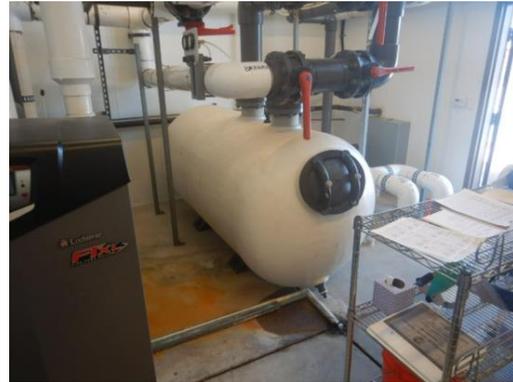
730 - Filter	Useful Life 15	Remaining Life 10
Lap Pool	Quantity 1	Unit of Measure Items
	Cost /Itm \$13,575	
	% Included 100.00%	Total Cost/Study \$13,575
Summary	Replacement Year 2031	Future Cost \$17,377

This is to replace the Pentair THS Series THS4296 sand filter.

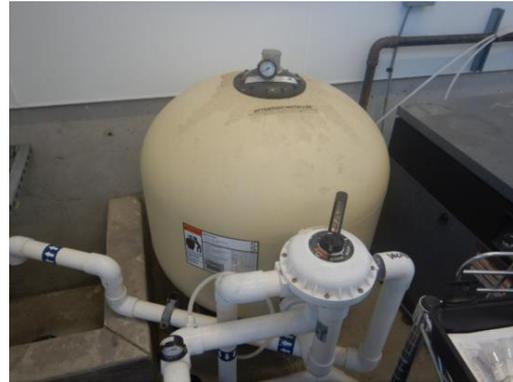
734 - Filter	Useful Life 14	Remaining Life 9
Wading Pool	Quantity 1	Unit of Measure Items
	Cost /Itm \$1,700	
	% Included 100.00%	Total Cost/Study \$1,700
Summary	Replacement Year 2030	Future Cost \$2,123

This is to replace the Pentair Triton II Commercial RR140C sand filter.

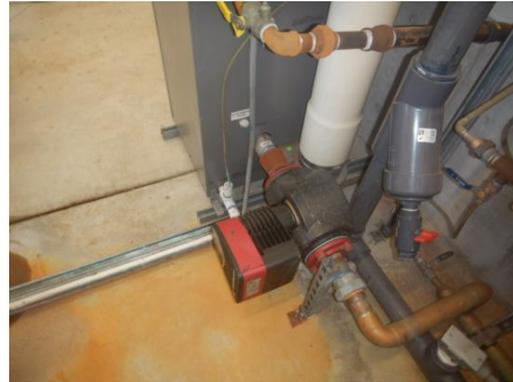
740 - Pumps	Useful Life 8	Remaining Life 3
Pool Grundfos Heater Pump	Quantity 1	Unit of Measure Items
	Cost /Itm \$2,035	
	% Included 100.00%	Total Cost/Study \$2,035
Summary	Replacement Year 2024	Future Cost \$2,191

This is to replace the Grundfos pool heater circulation pump.

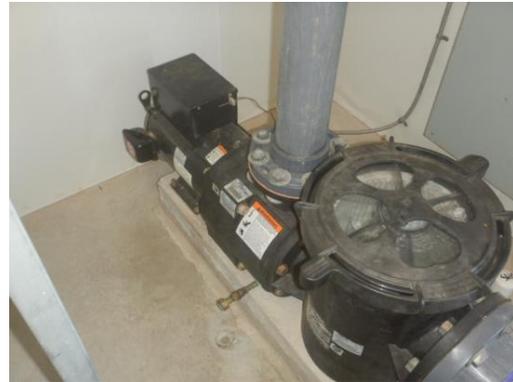
744 - Pumps	Useful Life 8	Remaining Life 3
Lap Pool Pentair 7.5 HP Pump	Quantity 1	Unit of Measure Items
	Cost /Itm \$6,315	
	% Included 100.00%	Total Cost/Study \$6,315
Summary	Replacement Year 2024	Future Cost \$6,801

This is to replace the Pentair 7.5 hp pump.

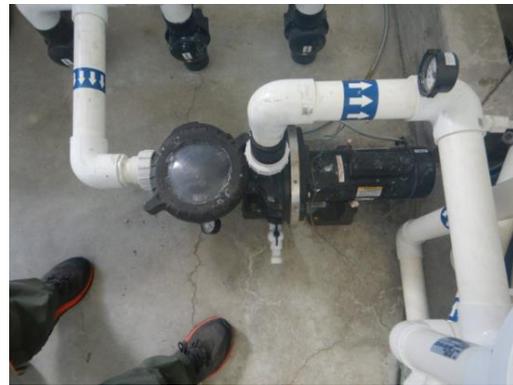
748 - Pumps	Useful Life 8	Remaining Life 0	
Wading Pool Sta Rite 2 HP Pump	Quantity 1	Unit of Measure Items	
	Cost /Itm \$1,875		
	% Included 100.00%	Total Cost/Study \$1,875	
Summary	Replacement Year 2021	Future Cost \$1,875

This is to replace the Sta Rite 2 hp pump.

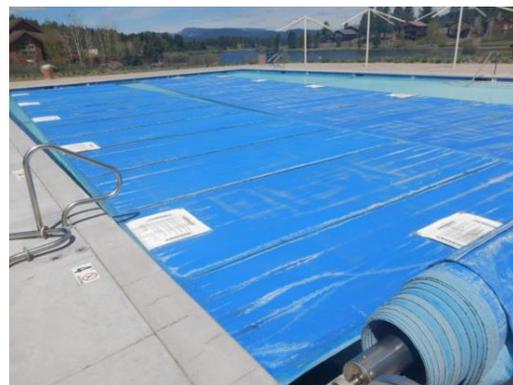
750 - Cover	Useful Life 8	Remaining Life 2	
Lap Pool	Quantity 1	Unit of Measure Items	
	Cost /Itm \$7,015		
	% Included 100.00%	Total Cost/Study \$7,015	
Summary	Replacement Year 2023	Future Cost \$7,370

This is to replace the pool cover. The cover should be properly cleaned and stored during non-use to ensure maximum life.

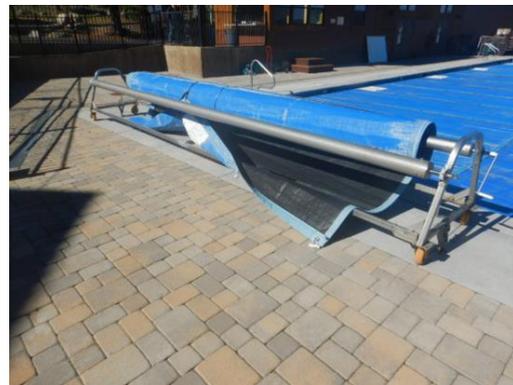
990 - Storage Reel	Useful Life 10	Remaining Life 4
Lap Pool Cover Reel	Quantity 1	Unit of Measure Items
	Cost /Itm \$2,940	
	% Included 100.00%	Total Cost/Study \$2,940
Summary	Replacement Year 2025	Future Cost \$3,245

This is to replace the lap pool cover reel.

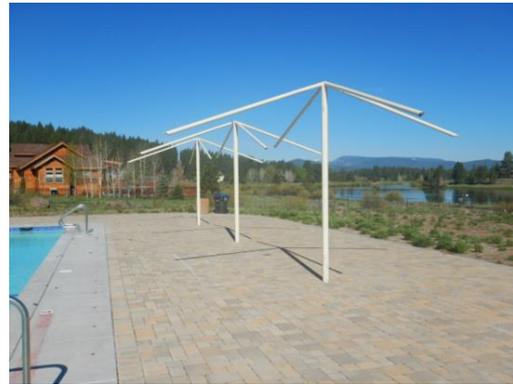
994 - Miscellaneous	Useful Life 10	Remaining Life 4
3 Pool Sunshades	Quantity 3	Unit of Measure Items
	Cost /Itm \$5,125	
	% Included 100.00%	Total Cost/Study \$15,375
Summary	Replacement Year 2025	Future Cost \$16,971

This is to replace the 10'x10' pool sunshade sails.

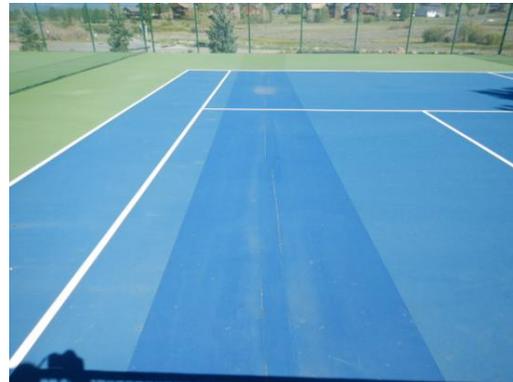
100 - Reseal	Useful Life 7	Remaining Life 4
13,200 sf [2] Tennis Courts	Quantity 13,200	Unit of Measure Square Feet
	Cost /SqFt \$2.44	
	% Included 100.00%	Total Cost/Study \$32,208
Summary	Replacement Year 2025	Future Cost \$35,552

This is to crack fill, seal and stripe the tennis courts.

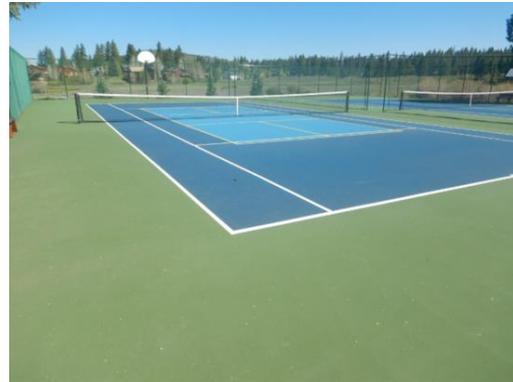
500 - Resurface	Useful Life 21	Remaining Life 18
13,200 sf [2] Tennis Courts	Quantity 13,200	Unit of Measure Square Feet
	Cost /SqFt \$5.65	
	% Included 100.00%	Total Cost/Study \$74,642
Summary	Replacement Year 2039	Future Cost \$116,416

This is to resurface the tennis courts utilizing an overlay, color coat and striping.

2021- Per client, both tennis courts were completely removed and replaced in 2017 for a total cost of \$96,800, which included perimeter fence removal. Seal and stripe was completed in 2018. Moderate cracking, especially the north court, was observed.
 2020- Per client 10/14/2020, \$4,000 is anticipated in 2023 for asphalt repairs.
 2018- Client advises \$60,000 was expended in 2017.
 2017- Estimate increased slightly from \$92,250 to \$82,000. Later in 2017, reduced to \$70,000 in 2017, as the fence cost was in this projection and should not have been.
 2016- \$90,000 anticipated to resurface in 2017 per client 8/4/2016 email.
 1992- Placed in service.

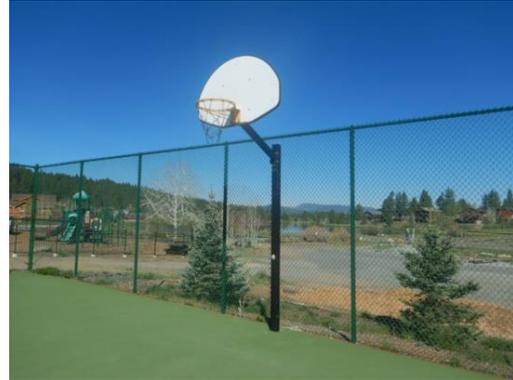
300 - Basketball Standard	Useful Life 15	Remaining Life 5
Tennis Court	Quantity 1	Unit of Measure Items
	Cost /Itm \$1,700	
	% Included 100.00%	Total Cost/Study \$1,700
Summary	Replacement Year 2026	Future Cost \$1,923

This is to replace the basketball standard.

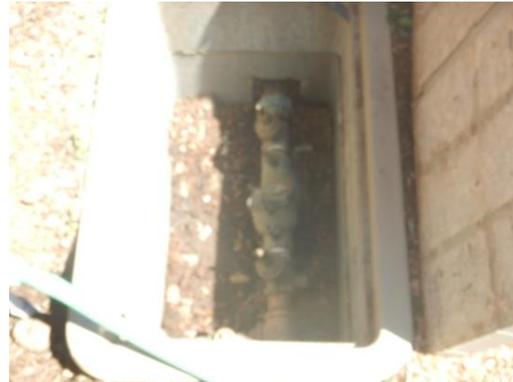
300 - Irrigation: Backflow Preventors	Useful Life 20	Remaining Life 5
Clubhouse South Buried Backflow	Quantity 1	Unit of Measure Items
	Cost /Itm \$2,260	
	% Included 100.00%	Total Cost/Study \$2,260
Summary	Replacement Year 2026	Future Cost \$2,557

This is to replace the backflow prevention valve.

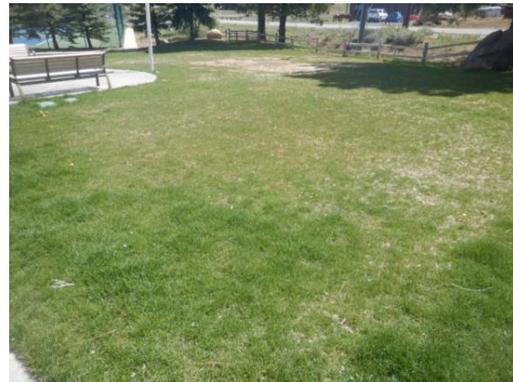
400 - Turf Renovation	Useful Life 20	Remaining Life 18
Flag Pole Lawn	Quantity 1	Unit of Measure Lump Sum
	Cost /LS \$16,810	
	% Included 100.00%	Total Cost/Study \$16,810
Summary	Replacement Year 2039	Future Cost \$26,218

This is to renovate the common area turf.

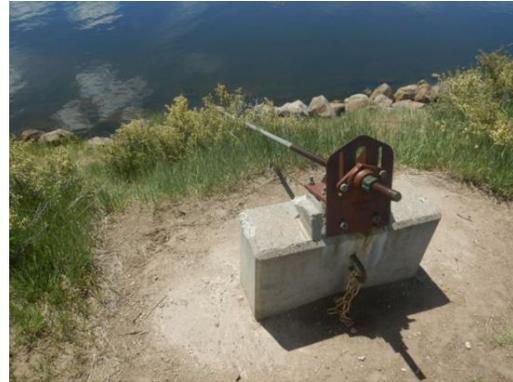
990 - Miscellaneous	Useful Life 30	Remaining Life 0
Pond Hlth Maintenance	Quantity 1	Unit of Measure Lump Sum
	Cost /LS \$3,960	
	% Included 100.00%	Total Cost/Study \$3,960
Summary	Replacement Year 2021	Future Cost \$3,960

This is to repair the pond drain.

2021- Work is anticipated per client.
 2016- The pond drain is antiquated in appearance and should be assessed for remaining life and cost to replace. Information received will further define this component.

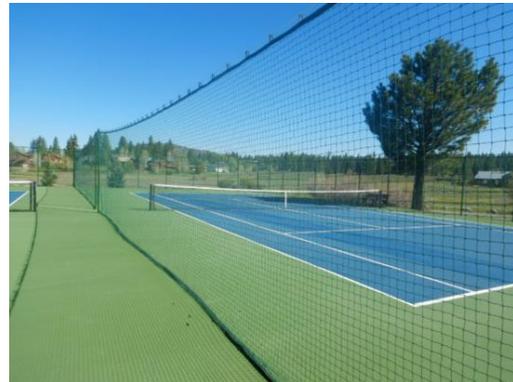
100 - Chain Link: 10'	Useful Life 30	Remaining Life 27
76 lf Mesh at Tennis Court Divider	Quantity 76	Unit of Measure Linear Feet
	Cost /l.f. \$40.00	
	% Included 100.00%	Total Cost/Study \$3,040
Summary	Replacement Year 2048	Future Cost \$5,921

This is to replace the tennis court center 10' chain link (mesh) fence divider.

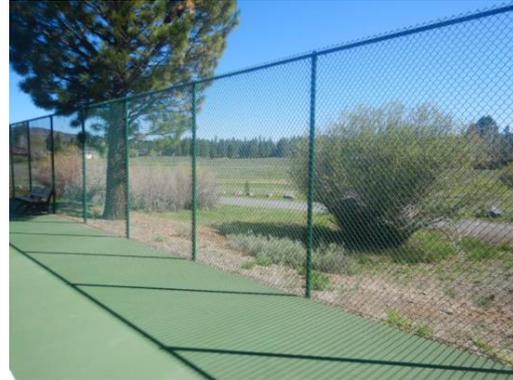
130 - Chain Link: 10'	Useful Life 30	Remaining Life 26
500 lf Tennis Court Perimeter	Quantity 500	Unit of Measure Linear Feet
	Cost /l.f. \$80.00	
	% Included 100.00%	Total Cost/Study \$40,000
Summary	Replacement Year 2047	Future Cost \$76,012

This is to replace the 10' chain link fencing.

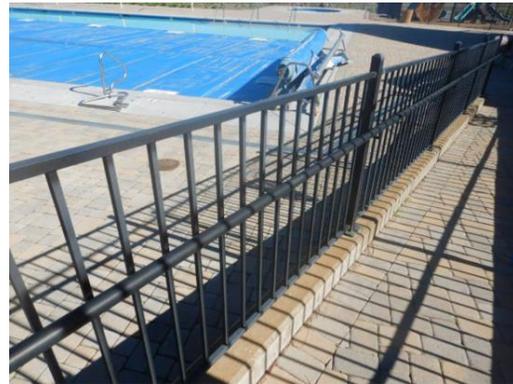
224 - Wrought Iron 684 lf Pool Perimeter (10%)	Useful Life 30 Quantity 684 Cost /l.f. \$40.00 % Included 10.00%	Remaining Life 25 Unit of Measure Linear Feet Qty * \$/l.f. \$27,360 Total Cost/Study \$2,736 Replacement Year 2046 Future Cost \$5,072
Summary

This is to replace the wrought iron fencing. This and another component provide for full replacement. With aggressive paint maintenance, this component's life may be extended. Painting is provided for within another component.

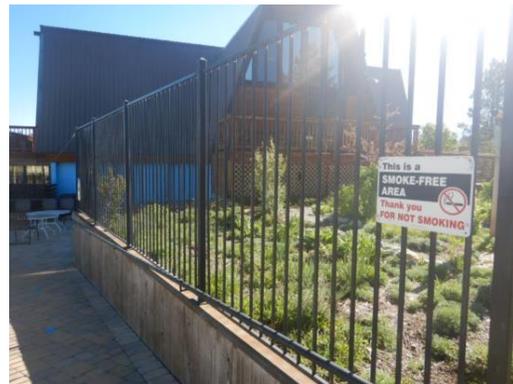
234 - Wrought Iron	Useful Life 30	Remaining Life 10
684 lf Pool Perimeter (90%)	Quantity 684	Unit of Measure Linear Feet
	Cost /l.f. \$40.00	Qty * \$/l.f. \$27,360
	% Included 90.00%	Total Cost/Study \$24,624
Summary	Replacement Year 2031	Future Cost \$31,521

This is to replace the wrought iron fencing. This and another component provide for full replacement. With aggressive paint maintenance, this component's life may be extended. Painting is provided for within another component.

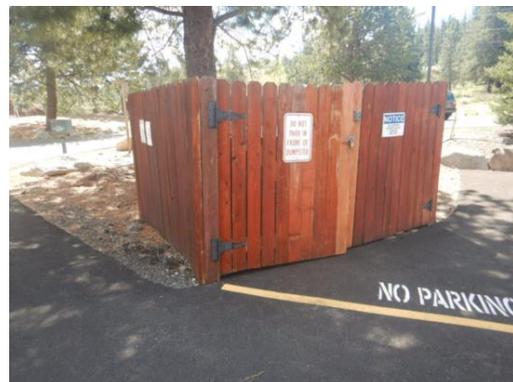
340 - Wood: 6'	Useful Life 18	Remaining Life 1
40 lf Trash Enclosure	Quantity 40	Unit of Measure Linear Feet
	Cost /l.f. \$150	
	% Included 100.00%	Total Cost/Study \$6,000
Summary	Replacement Year 2022	Future Cost \$6,150

This is to replace the 6' wood fencing including discarded fence material removal and disposal.

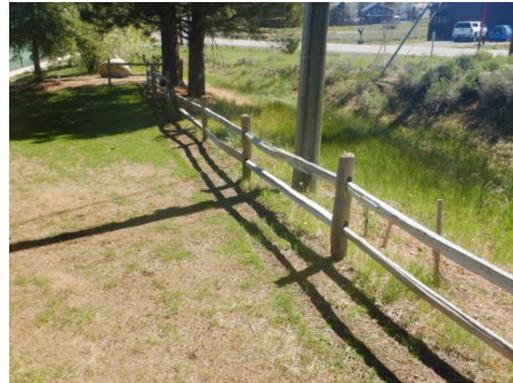
360 - Wood: Split Rail	Useful Life 25	Remaining Life 1
281 lf Clubhouse North Perimeter	Quantity 281	Unit of Measure Linear Feet
	Cost /l.f. \$17.00	
	% Included 100.00%	Total Cost/Study \$4,777
Summary	Replacement Year 2022	Future Cost \$4,896

This is to replace the split rail fencing.

2021- Remaining life reduced from 2028 to 2022 for complete replacement per client.

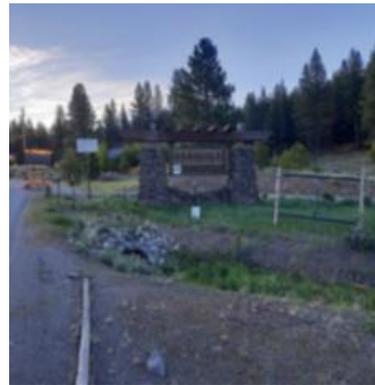
714 - Wood Monument	Useful Life 15	Remaining Life 2
Cobble Base Monument W/Trellis/Signage- West Entry	Quantity 1	Unit of Measure Items
	Cost /Itm \$10,000	
	% Included 100.00%	Total Cost/Study \$10,000
Summary	Replacement Year 2023	Future Cost \$10,506

This is to replace the cobble base monument at the west entrance south side of street. Includes wood signage with stone base and trellis tops. Cost will vary greatly dependent upon design.

2021- Cost increased from \$6,000 to \$10,000. Remaining life increase from 2022 to 2023 for complete replacement per client. There is a 2nd cobble base monument on the west entrance north side of the street is longer HOA but may be responsible to remove in the future per client.

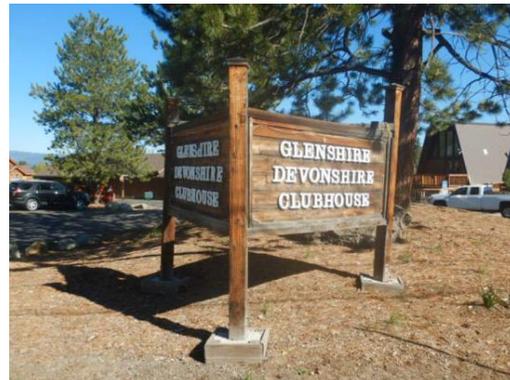
718 - Wood Monument	Useful Life 15	Remaining Life 1
Clubhouse Tri-Post Monument	Quantity 1	Unit of Measure Items
	Cost /Itm \$6,000	
	% Included 100.00%	Total Cost/Study \$6,000
Summary	Replacement Year 2022	Future Cost \$6,150

This is to replace the custom identity wood monument at the clubhouse Includes 1 set of wood signage and wood posts. Cost will vary greatly dependent upon design.

2021- Remaining life set 2022 for complete replacement per client.

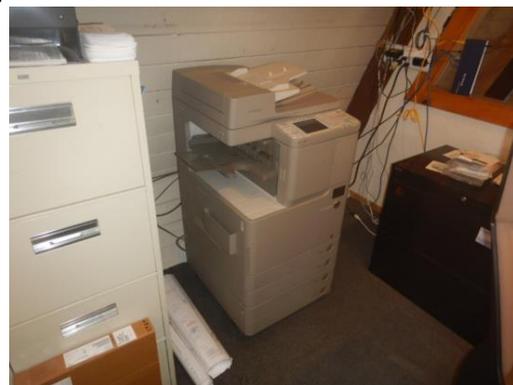
300 - Copier	Useful Life 10	Remaining Life 1	
Office Copier	Quantity 1	Unit of Measure Items	
	Cost /Itm \$10,180		
	% Included 100.00%	Total Cost/Study \$10,180	
Summary	Replacement Year 2022	Future Cost \$10,435

This is to replace the Canon C2030 Image Runner printer.

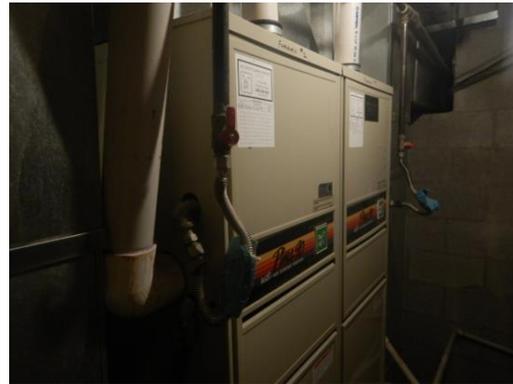
200 - Furnace	Useful Life 15	Remaining Life 2	
2 Clubhouse- Furnaces #4 & #2	Quantity 2	Unit of Measure Items	
	Cost /Itm \$5,657		
	% Included 100.00%	Total Cost/Study \$11,314	
Summary	Replacement Year 2023	Future Cost \$11,887

This is to replace the HVAC system. It is possible that sub-components of these systems can be replaced or rebuilt to extend life.

2021- Per client 9/15/2021, remaining life extended from 2022 to 2023.

2016- There are 4 total units. Units #1 and #2 are for parts use only and are not included in the reserve study per client.

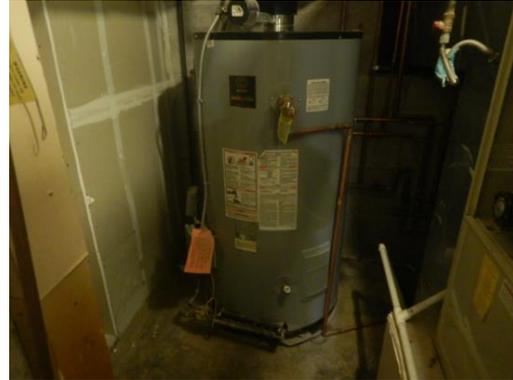
600 - Water Heater	Useful Life 12	Remaining Life 1
Clubhouse	Quantity 1	Unit of Measure Items
	Cost /Itm \$3,395	
	% Included 100.00%	Total Cost/Study \$3,395
Summary	Replacement Year 2022	Future Cost \$3,480

This is to replace the State 100 gallon water heater including discarded unit disposal.

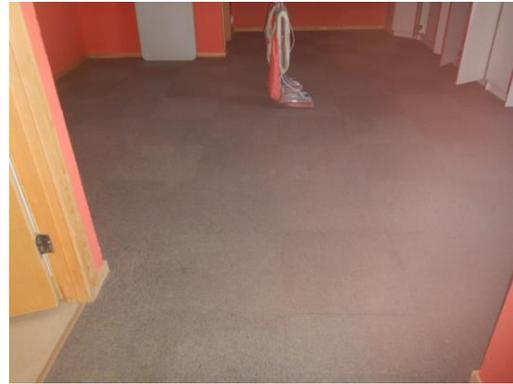
204 - Carpeting	Useful Life 15	Remaining Life 9
65 Sq. Yds. Clubhouse Lower Floor	Quantity 65	Unit of Measure Square Yard
	Cost /SqYd \$80.00	
	% Included 100.00%	Total Cost/Study \$5,200
Summary	Replacement Year 2030	Future Cost \$6,494

This is to replace the carpeting.

lower floor- 560 sf
 stairs to office- 23 sf

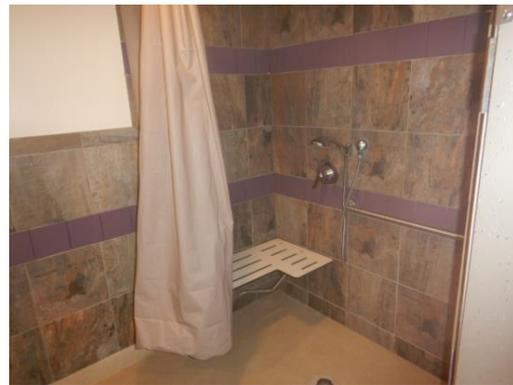
400 - Tile	Useful Life 22	Remaining Life 15
1,048 sf Downstairs Pool Bathroom Wall Tile	Quantity 1,048	Unit of Measure Square Feet
	Cost /SqFt \$13.55	
	% Included 100.00%	Total Cost/Study \$14,200
Summary	Replacement Year 2036	Future Cost \$20,566

This is to replace the wall tile.

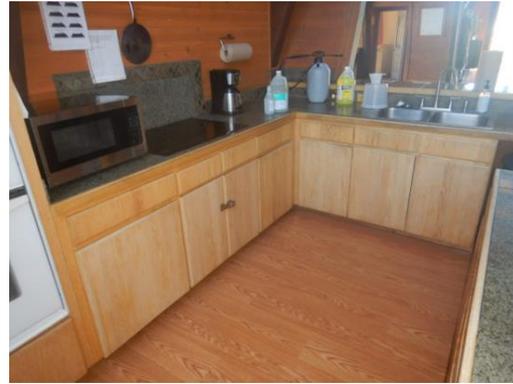
700 - Vinyl	Useful Life 18	Remaining Life 2
1,895 sf Clubhouse	Quantity 1,895	Unit of Measure Square Feet
	Cost /SqFt \$6.80	
	% Included 100.00%	Total Cost/Study \$12,886
Summary	Replacement Year 2023	Future Cost \$13,538

This is to replace the vinyl plank flooring.

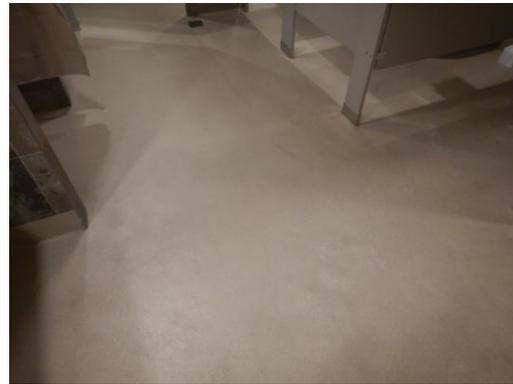
920 - Coatings	Useful Life 12	Remaining Life 5
734 sf CH Downstairs Pool Bathroom Epoxy	Quantity 734	Unit of Measure Square Feet
	Cost /SqFt \$11.00	
	% Included 100.00%	Total Cost/Study \$8,074
Summary	Replacement Year 2026	Future Cost \$9,135

This is to install a proprietary floor coating system. Estimate dependent on manufacturer and scope of work.

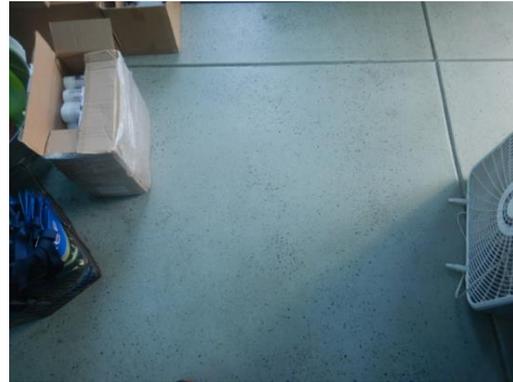
924 - Coatings	Useful Life 12	Remaining Life 7
314 sf Pool Pass Building Office Epoxy Floor	Quantity 314	Unit of Measure Square Feet
	Cost /SqFt \$7.00	
	% Included 100.00%	Total Cost/Study \$2,198
Summary	Replacement Year 2028	Future Cost \$2,613

This is to install a proprietary floor coating system. Estimate dependent on manufacturer and scope of work.

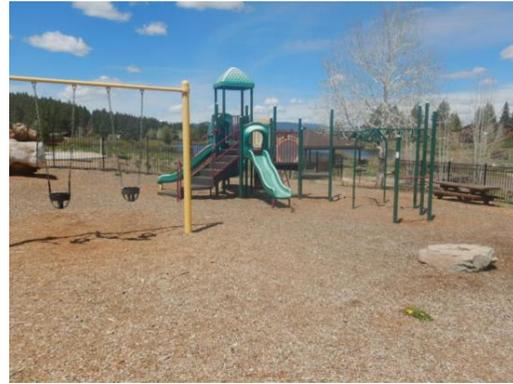
100 - Tot Lot: Play Equipment Playground- Little Tikes Structure	Useful Life 18 Quantity 1 Cost /Itm \$11,315 % Included 100.00% Replacement Year 2022	Remaining Life 1 Unit of Measure Items Total Cost/Study \$11,315 Future Cost \$11,598
---	--	--

This is to replace the Little Tikes tot lot play equipment.

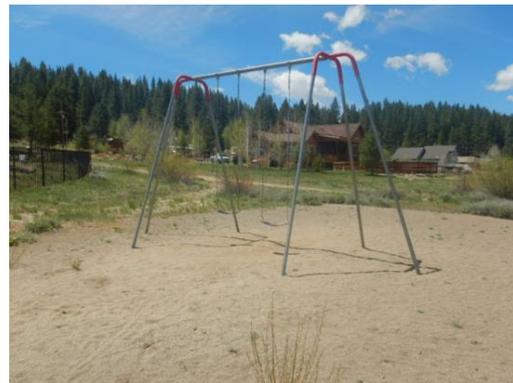
104 - Tot Lot: Play Equipment 2 Swing Sets	Useful Life 25 Quantity 2 Cost /Itm \$1,700 % Included 100.00% Replacement Year 2036	Remaining Life 15 Unit of Measure Items Total Cost/Study \$3,400 Future Cost \$4,924
---	---	---

This is to replace the 2-seat swing sets.

- 1- 2-seat infant
- 1- 2-seat toddler
